Fiscal 2005 Study on Verification of Seaweed Bed Development in Omaezaki Port

The Basic Plan for Seaweed Bed Development in Omaezaki Port intends to develop seaweed beds by using an environmentally-friendly breakwater; zoospores are supplied from retarding areas where seaweed is grown, so that new seaweed beds are developed around the breakwater.

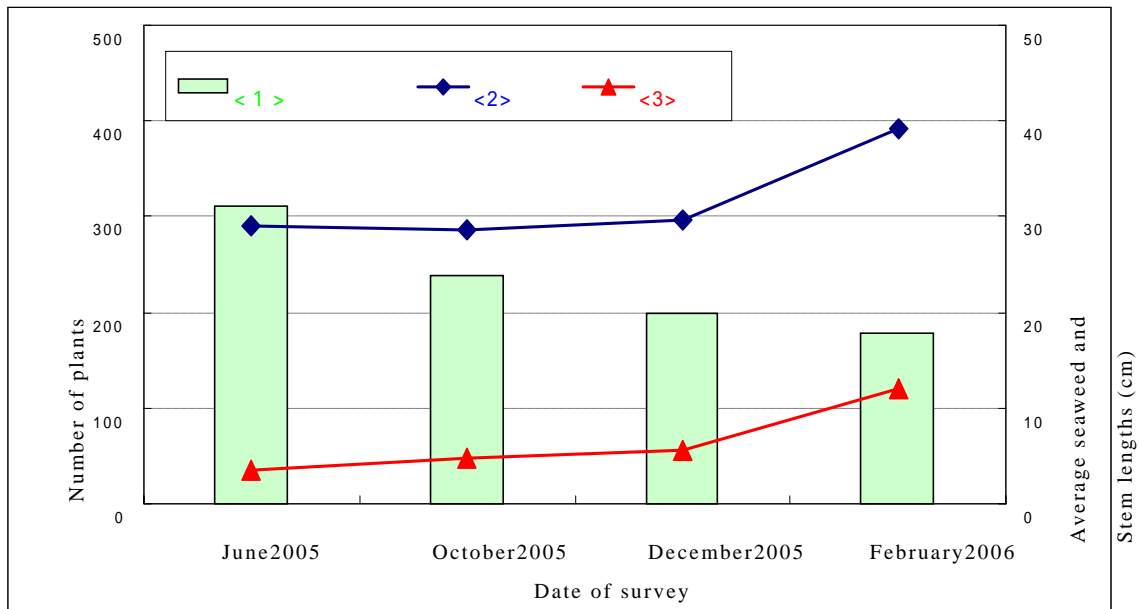
<1> Number of plants per chamber <2> Average seaweed length <3> Average stem length

Figure 3-1 Population, average seaweed length, and average stem length of sea trumpet in fixed-point survey

The results of the fixed-point survey are shown in Figure 3-1, and the growth of sea trumpet in a retarding area is shown progressively in Photo 3-1.

The second-generation juveniles germinated in fiscal 2004 grew steadily in the retarding areas. In 2005, germination of third-generation plants was observed. Therefore, there was a mixed community of first- to third-generation plants including mother plants. The population of sea trumpet excluding mother plants decreased probably because of natural depletion and destructive waves associated with typhoons. In fact, newly germinated juveniles were not found in the February 2006 survey.

Average seaweed and stem lengths remained almost unchanged from June to December 2005, and significant growth was observed in the February 2006 survey. It is inferred that the seaweed grew during the June to December period but shoot tip injury occurred at the same time.

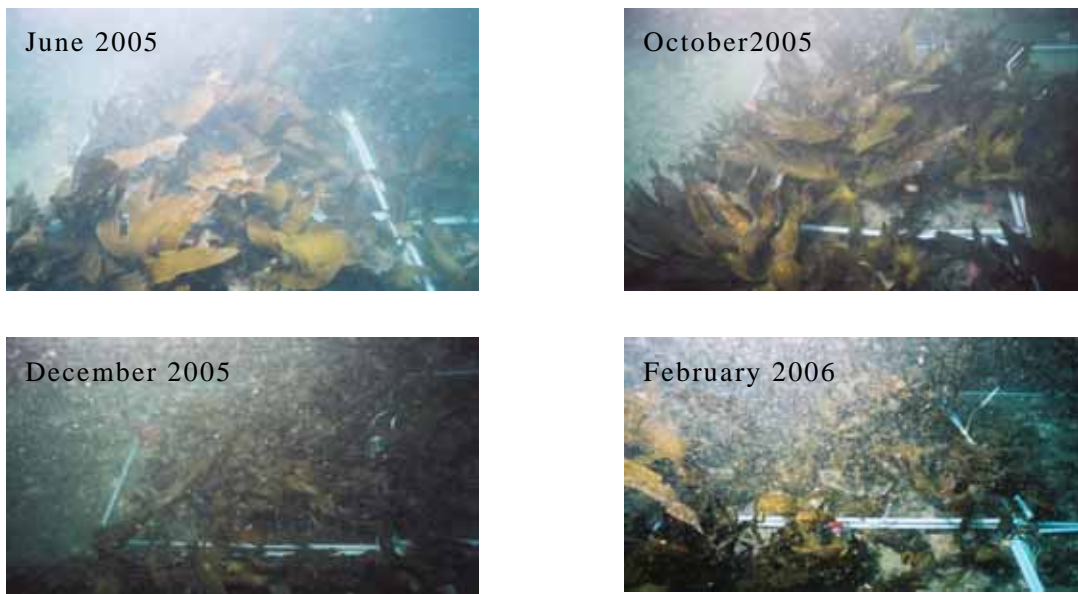
Photo 3-1 Growth of sea trumpet in retarding area 3 of No. 41 caisson

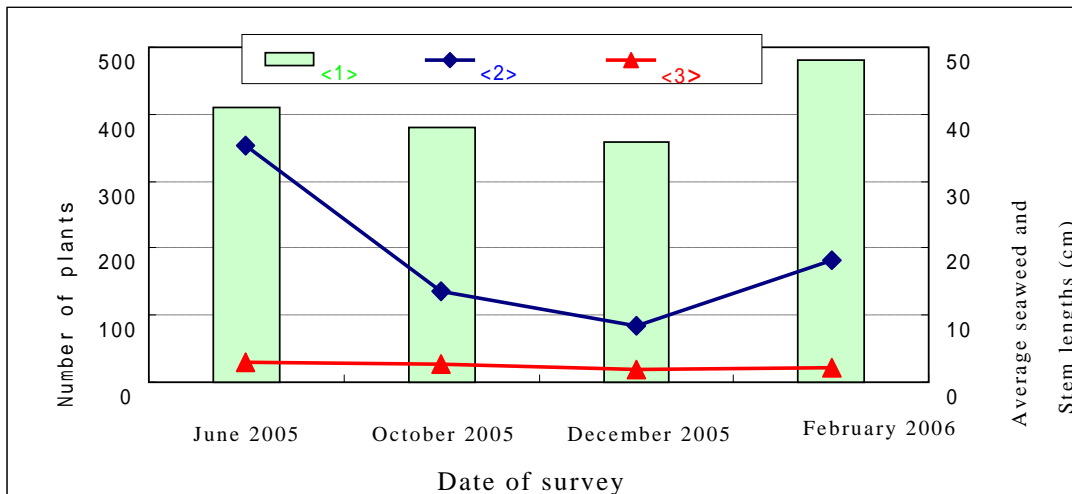
<1>Number of plants per chamber <2>Average seaweed length <3>Average stem length

Figure 3-2 Population, average seaweed length, and average stem length of sea trumpet in traverse-line survey

The results of the traverse-line survey are shown in Figure 3-2, and the growth of sea trumpet in the frontal area of a caisson is shown progressively in Photo 3-2.

The second-generation juveniles germinated in 2004 disappeared by December 2004. Then, germination of third-generation plants was observed in 2005, and seaweed beds developed widely in front of the caissons mainly around the foot protection blocks. The population of sea trumpet decreased from June to December 2005, presumably because of feeding damage, natural depletion, and waves. New plants emerged and the population increased in the February 2006 survey. The same pattern of seasonal variation (a decrease in population from summer to fall and an increase from winter to spring) was also observed in fiscal 2004.

The seaweed length of sea trumpet decreased from June to December 2005. It is inferred that, during this period, the seaweed grew but the population decreased because of dropouts, so that the average seaweed length decreased. During the period from December 2005 to February 2006, the average length was suppressed by the addition of small juveniles.

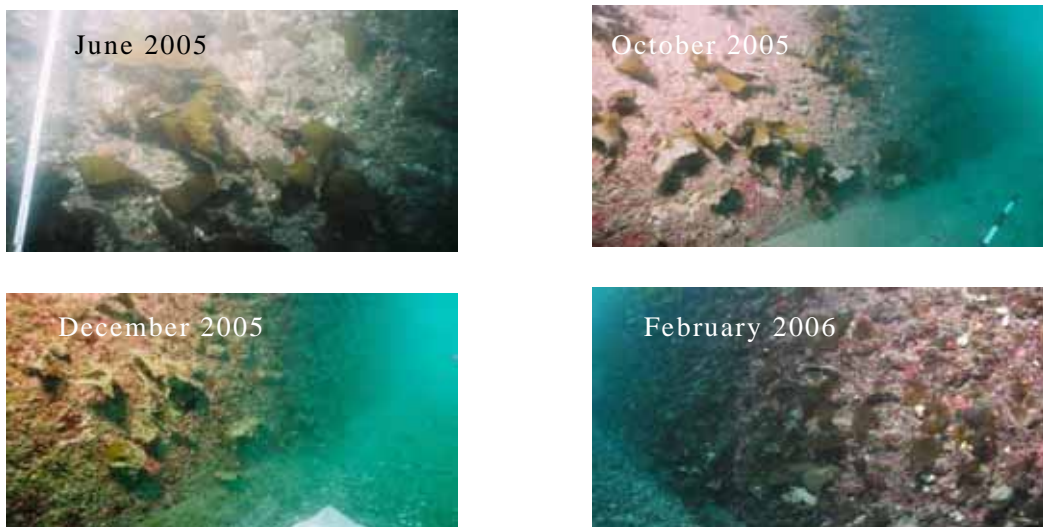
Photo 3-2 Growth of sea trumpet plants in front of retarding area 3 of No.41 caisson

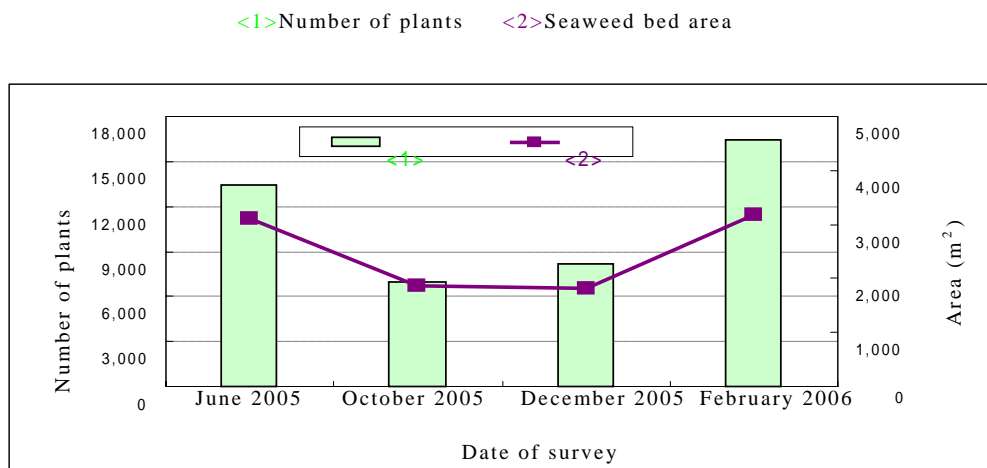
Figure 3-3 Approximate population of sea trumpet plants and area of seaweed beds in complementary survey

As shown in Figure 3-3, the population of sea trumpet plants and the area of seaweed beds decreased significantly by December 2005 and then increased. The same trend of population decrease from summer to fall and increase from winter to spring was observed in fiscal 2004, although disappearance of seaweed beds due to feeding damage was observed in December 2005.

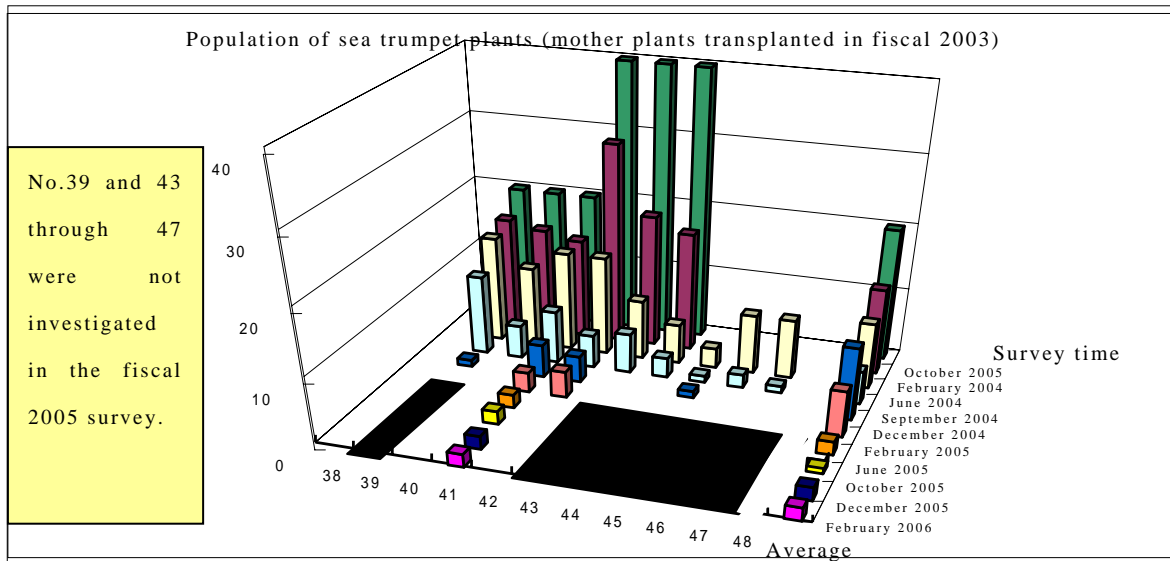
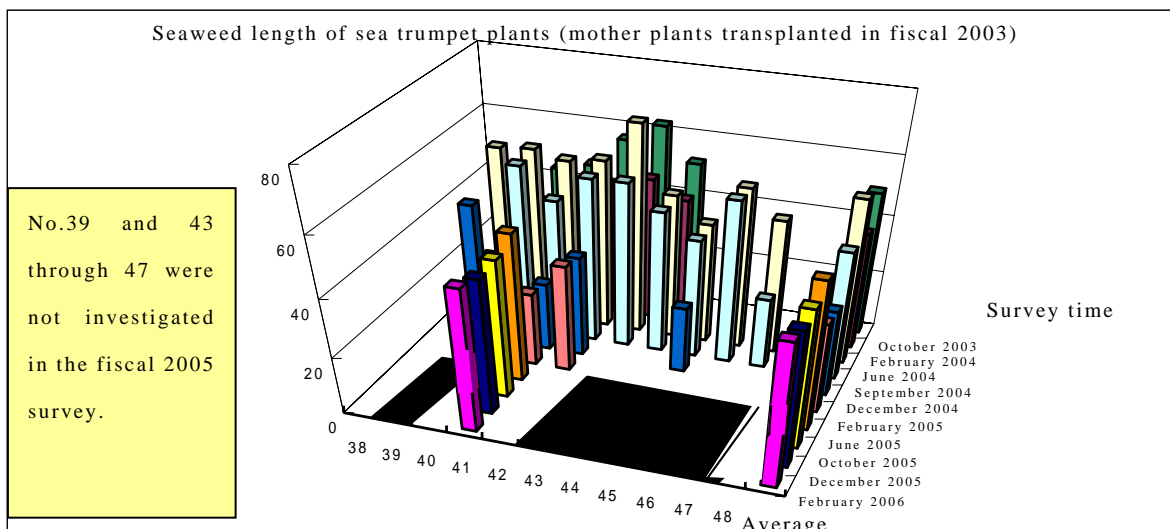
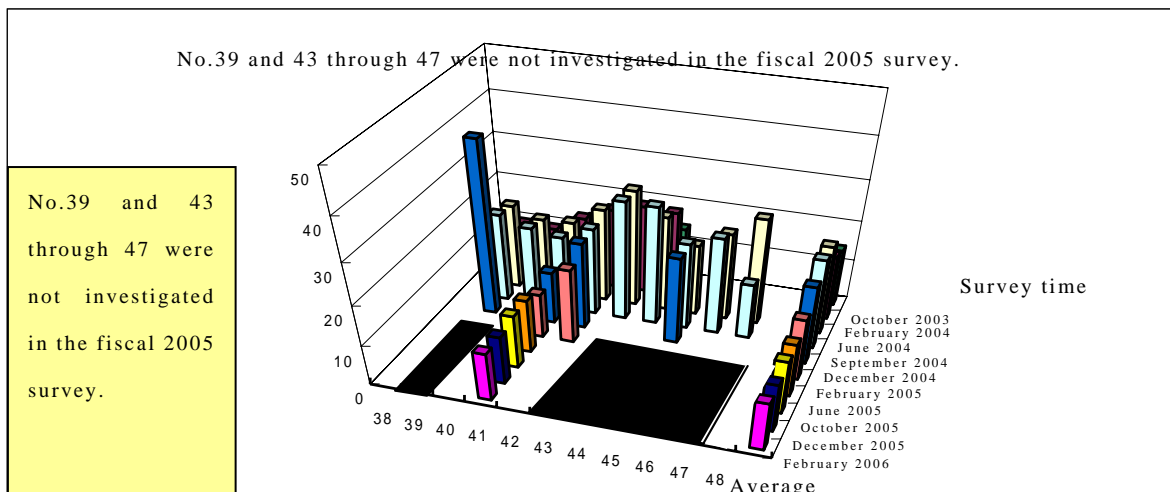
Figure 3-4 Development of sea trumpet plants (mother plants transplanted in fiscal 2003) in retarding areas with time

Note 1. The fixed-point survey was conducted in retarding area 1 of No. 38 and retarding area 3 of the other caissons.

The development of sea trumpet plants in the retarding areas with time since fiscal 2003 is summarized in Figure 3-4.
